Real Estate Inspection Report

June 22, 2010

**2241 Branden Street
Los Angeles, CA 90026**

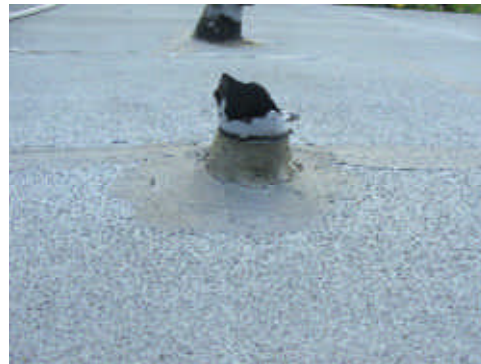
Needs Attention: There is a damaged plumbing vent line that needs repair above the roof.

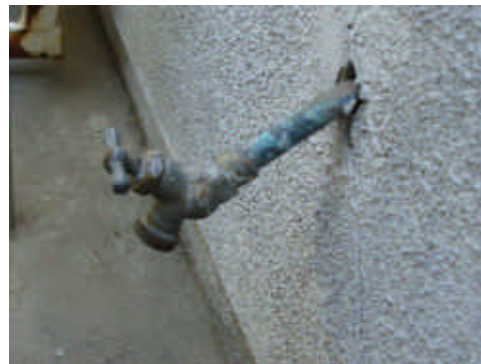
Needs Attention: There is loose and damaged piping at the hose bibs on the left side.

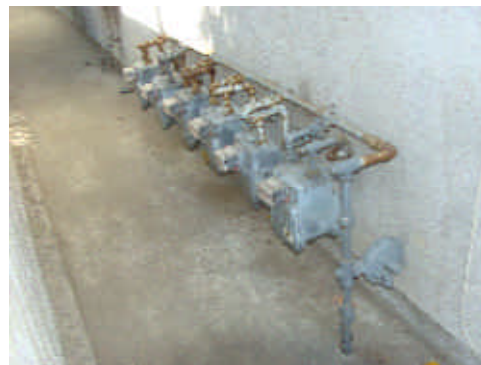
The gas meters are located on the left side of the building.

There is no automatic seismic gas shut-off valve on the main gas line. This may need to be installed before the close of escrow.

It is advised to have the gas provider inspect the gas system to determine its condition and check all the gas appliances and fixtures. This is usually a free service.

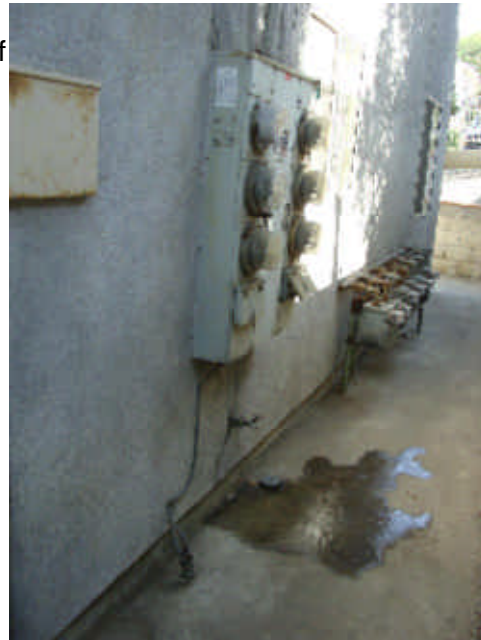
The main electrical panels are
located on the left exterior side of
the building.

Service Amperage - 60 Amps for each unit. 40 Amps for the house
panel.

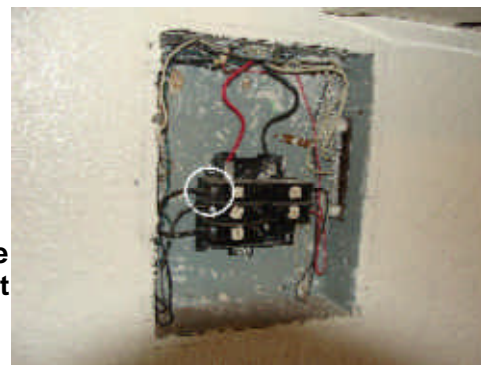
Not Acceptable: There is more than one wire connected to a single circuit breaker, where only one wire should be connected to each breaker. This can sometimes cause overloading of the wires or breakers. It also can cause the wires to have improper contact with the breaker and arc between the wire and the breaker. This was found in the house panel and in the units also.

It is advisable to have an electrician examine the system and make all needed repairs to ensure a properly installed and correctly operating electrical system. This investigation of the system should be done prior to the expiration of the contingency period so the repair or replacement costs are known and unwanted expenses are avoided. It is expected that when the electrical specialist checks out the system they will find more problems as this is a general inspection and not designed to list every fault but to isolate areas in need of further detailed inspections.

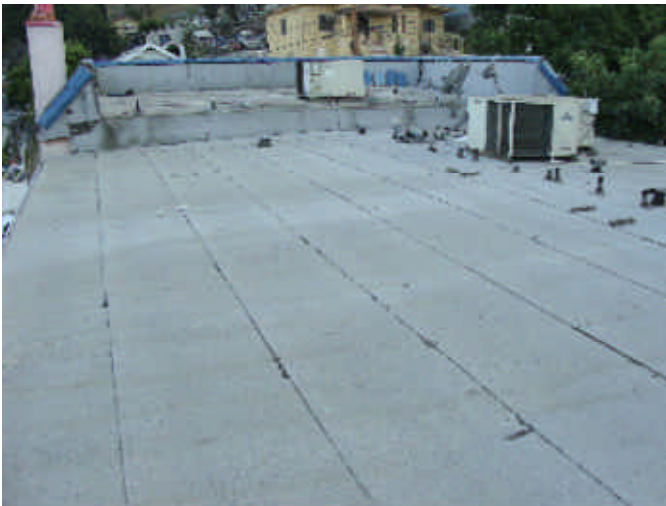
ROOF STYLE: The roof is a flat roof with a low pitch.

The roofing material on the low sloped roof is rolled composition roofing (BUR or build up roofing or cap sheet)

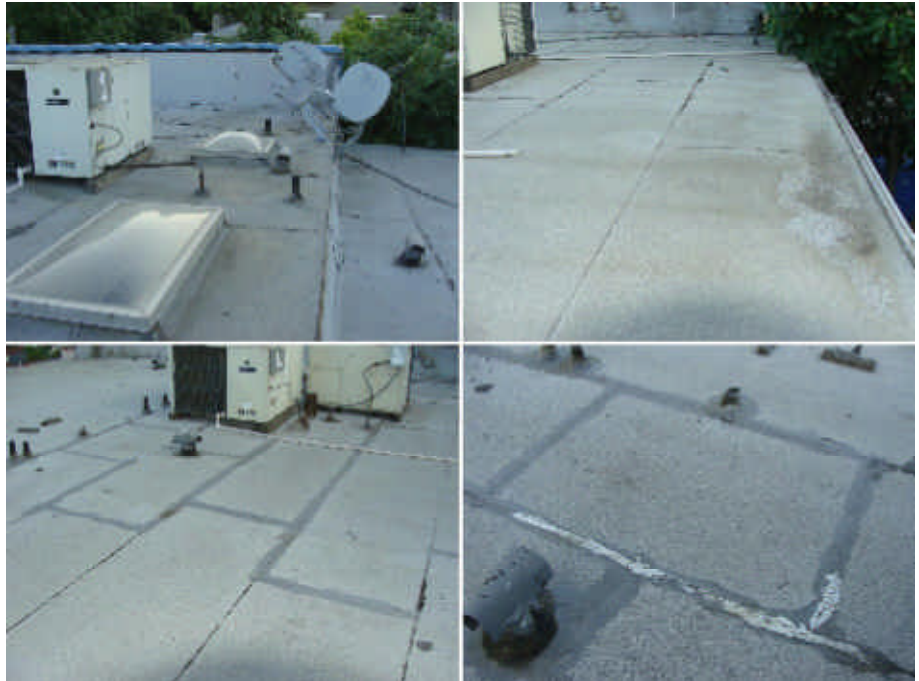
Needs Attention: On the low sloped / flat roof, there are bubbled areas of roofing material and the roof deck is soft under foot. This is an indication that some moisture has gotten under the material.

There are areas where the roof is poorly sloped and water collects and ponds and does not fully drain off. This can lead to premature wear and failure. A roofing specialist may be able to remedy this.

There are areas of previous temporary patching which are deteriorated and need further repairs.

A licensed roofing contractor should examine the roof and make all needed repairs (or replacements) to ensure a long lasting leak free condition. The roofing contractor may find more problems with the roof and this is why it is being referred to a specialist so they can determine all the problems and give an accurate estimate of the costs involved.

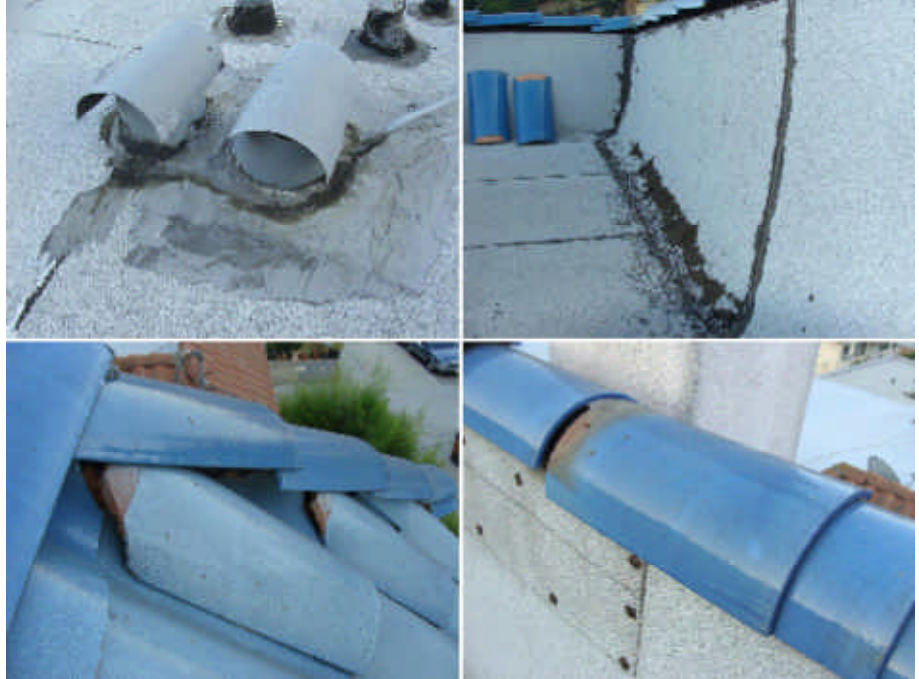
Needs Attention: The flashing is not standard and may not be a reliable installation, it will require high maintenance to ensure that it remains leak free. The mastic is cracked in areas and is not reliable to ensure a watertight seal.

There are loose tiles or gaps at the tile edges. There are areas of patching to the parapet walls which are deteriorated and need repair.

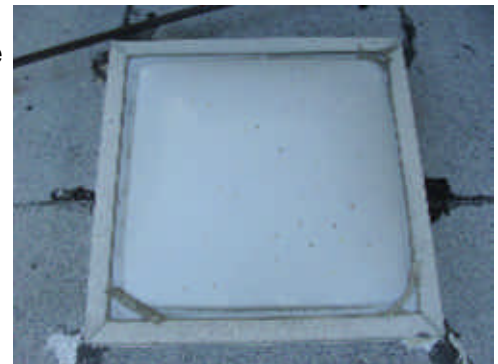
Needs Attention: The skylight lens are cracked and some have been patched.

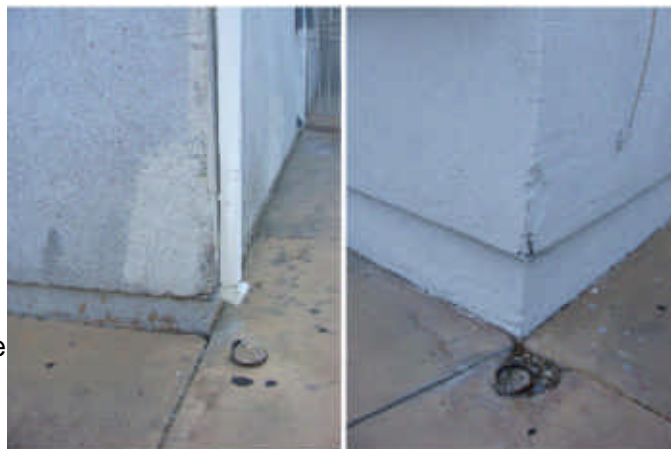
CONDITION: Needs Attention:
There is damage to the exterior surface and repairs to the plaster/stucco are needed to ensure there is no water intrusion.

For example there are areas of previous rough patching which are deteriorated at the right front and right rear corners of the building (It appears the protective pipes have been removed and there has been contact from autos.).

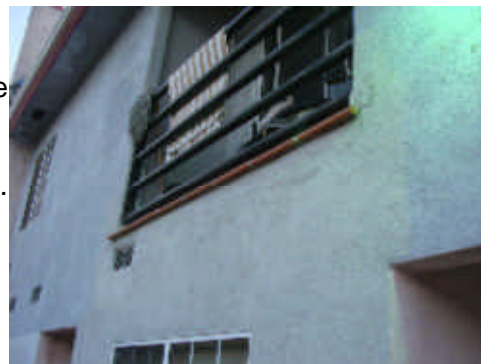
There is previous rough patching below the balconies, and this is cracking and deteriorated outside unit #4. There are patched areas and some open gaps in the plaster near the electrical meters.

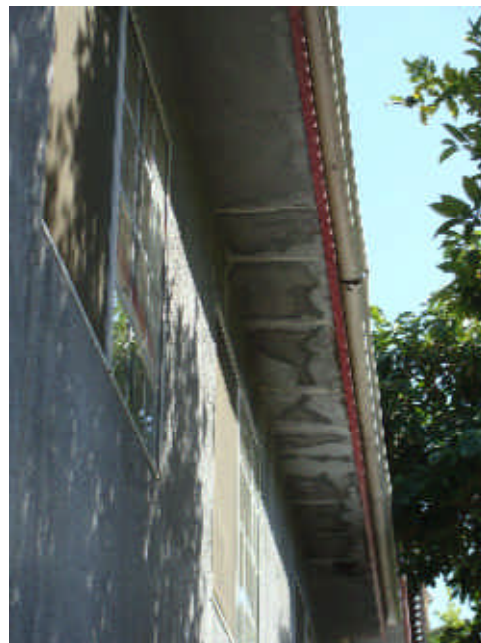
There are areas of moisture staining in the soffits at the left and right roof eaves, and moisture staining on the left exterior walls.

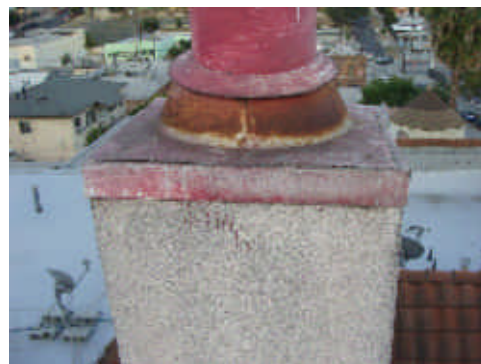
Needs Attention: The chase cover does not appear to be properly sloped to drain and has areas of rusting and non-standard patching which is deteriorated.

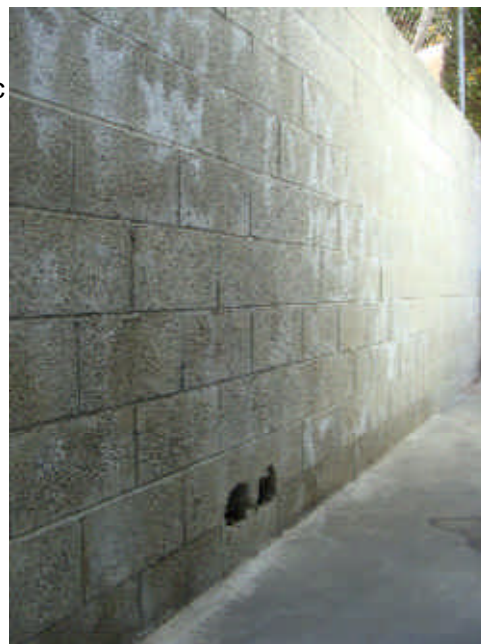
Needs Attention: The retaining walls have no visible weep holes in them to relieve the hydro-static pressure that builds up behind them. A proper drainage system should be designed and installed. There are areas of moisture staining on the walls. Some damaged blocks were noted at the left side near the bath of the building, and there appears to be missing grout inside these blocks.

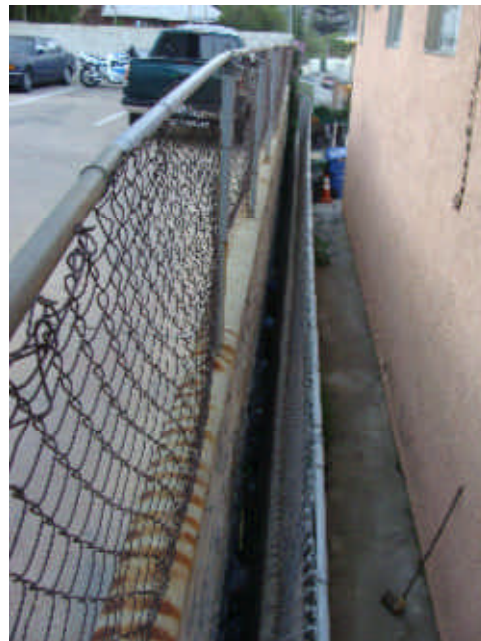
There is accumulated debris between the walls along the right side, and the neighboring wall appears to be leaning out of plumb. This area does not appear to have proper drainage.

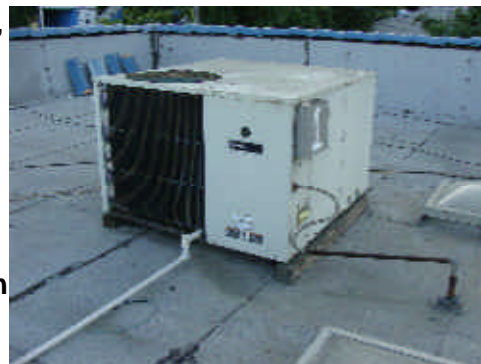
**The flexible gas line passes
through the wall of the
furnace, a standard installation
requires that the flex line
remain outside the wall of the
furnace.**

**It is recommended a heating contractor fully evaluate the heating
system and make all needed repairs, before the close of escrow.**

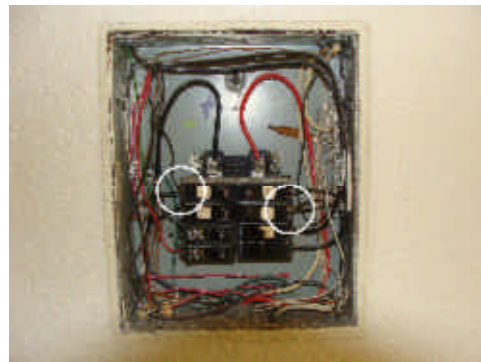
**PANEL CONDITION: There are
'Double Taps' where 2 wires
attach to one breaker, this is
incorrect. Two of these were
noted.**

**The breaker labeled AC was
found shut off - the reasons
for this was not apparent. The
breaker was turned on for testing the system and then turned
back off.**

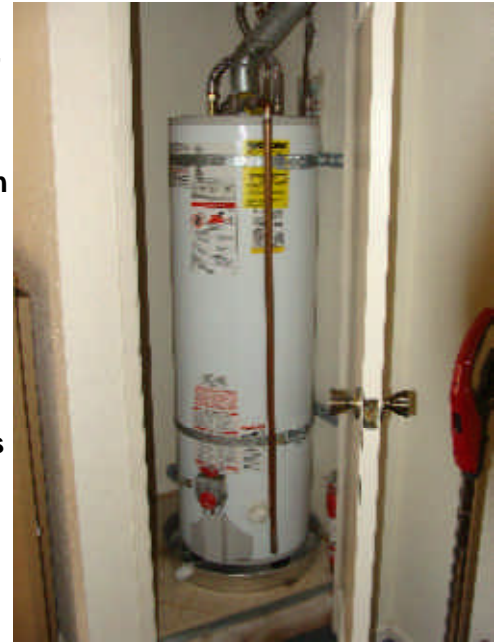
The water heater is located in a living room closet. it is gas fired, 40 gallons, 8 years old.

CONDITION: Needs Attention:
There is not the required drain line for the catch pan under the water heater to prevent water damage to the building in case of leaking.
The Temperature / Pressure Relief safety valve does not have the required drain pipe extending to a safe location as required.
The water heater is older and well into its expected useful life span.

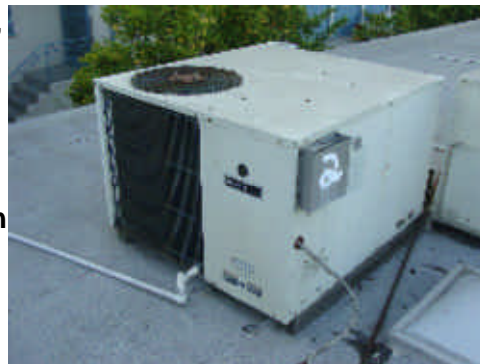
Not Acceptable: The furnace did not operate when tested. The flexible gas line passes through the wall of the furnace, a standard installation requires that the flex line remain outside the wall of the furnace.

It is advised to have a licensed heating contractor examine the furnace and make all needed repairs to ensure a safe and properly operating system.

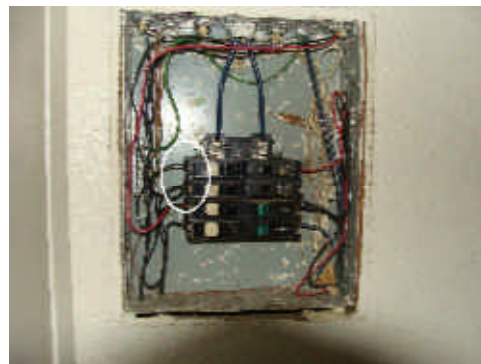
PANEL CONDITION: There are 'Double Taps' where 2 wires attach to one breaker, this is incorrect. Two of these were noted.

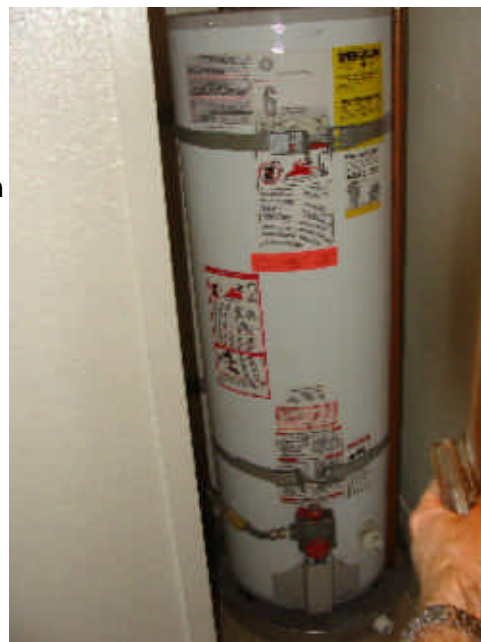
The water heater is located in a hallway closet. it is gas fired, 40 gallons, 9 years old.

The water heater is older and well into its expected useful life span.

The water heater is not sitting level and is leaning, it works best if it is fully upright and should be properly installed.

Not Acceptable: This does not have the necessary openings/ grills to allow the required fresh air for combustion.

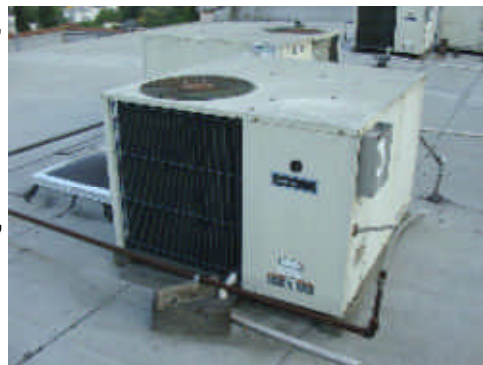
The flexible gas line passes through the wall of the furnace, a standard installation

requires that the flex line remain outside the wall of the furnace.

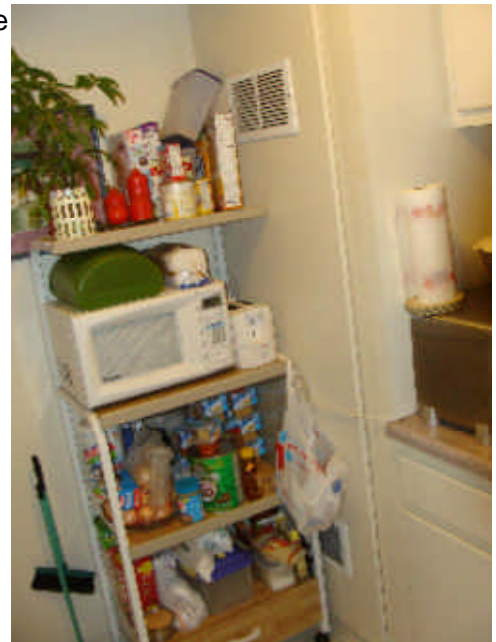
The water heater is located in the kitchen closet.
The closet was blocked by shelving and the water heater was not accessible.

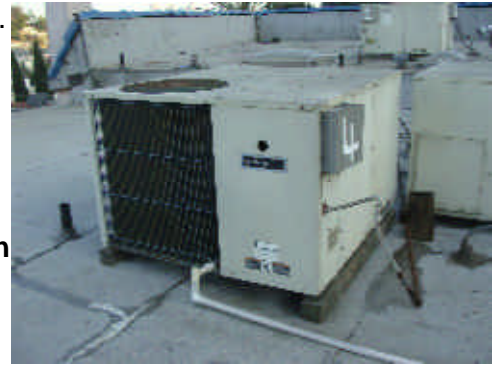
The flexible gas line passes through the wall of the furnace, a standard installation requires that the flex line remain outside the wall of the furnace.

The furnace is older and is well into its expected useful life.

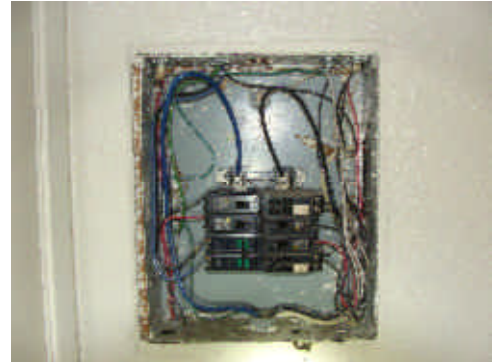
The sub panel is located in the master bedroom. Serviceable.

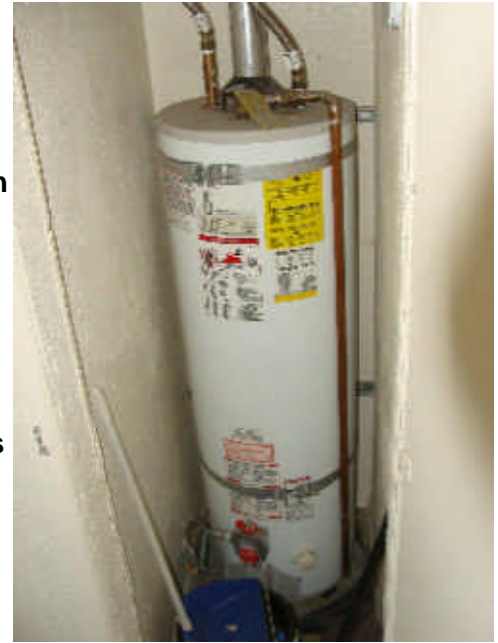
The water heater is located in a hallway closet. it is gas fired, 40 gallons, 9 years old.

CONDITION: Needs Attention:
There is not the required drain line for the catch pan under the water heater to prevent water damage to the building in case of leaking.
The Temperature / Pressure Relief safety valve does not have the required drain pipe extending to a safe location as required.
The water heater is older and well into its expected useful life span.

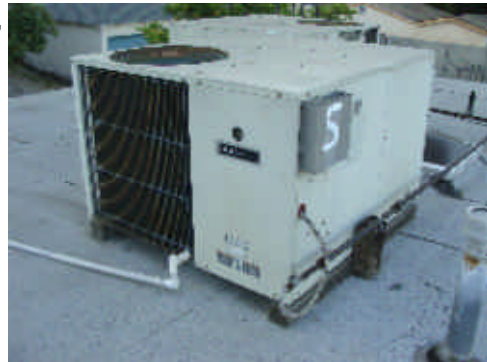
The flexible gas line passes through the wall of the furnace, a standard installation requires that the flex line remain outside the wall of the furnace.

It is advised to have a licensed heating contractor examine the furnace and make all needed repairs to ensure a safe and properly operating system.

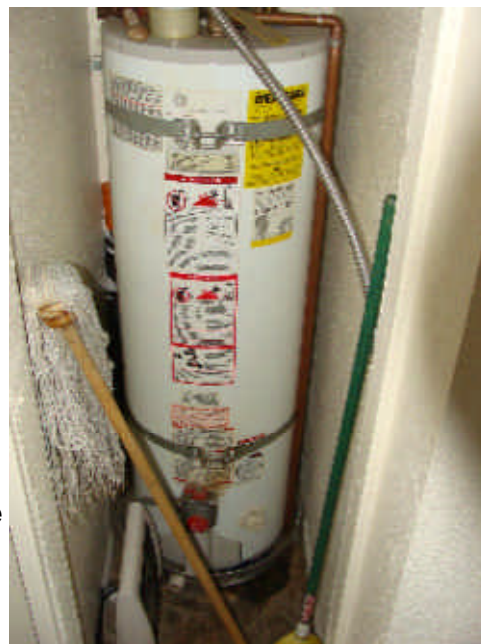
The Temperature / Pressure Relief safety valve does not have the required drain pipe extending to a safe location as required.

The water heater is older and well into its expected useful life span.
