# Real Estate Inspection Report

March 24, 2010.

**4443 Willow Brook Ave  
Los Angeles, CA 90029**

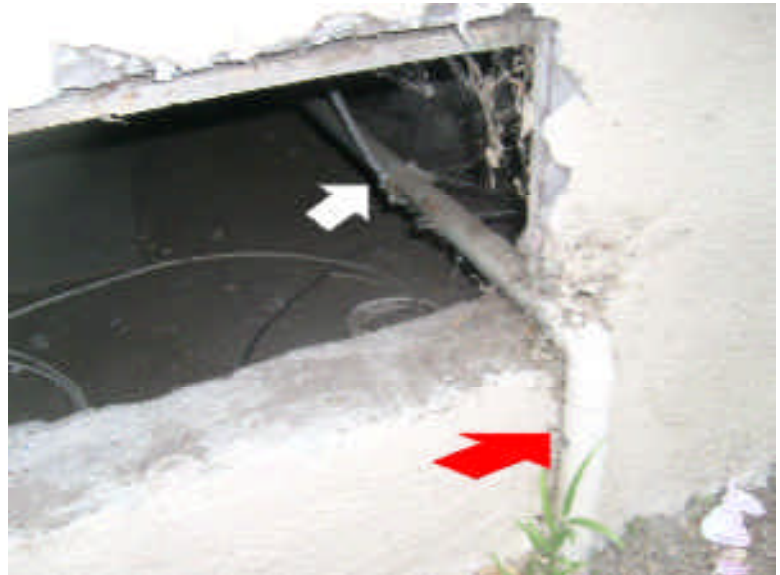
MAIN WATER LINE  
MATERIAL:

Copper piping is viewed coming out of the ground by the building and as the main line runs underground from the street to the building, this appears to be the main water line. As the underground portion is not seen, no assumption is made as to its condition or material.

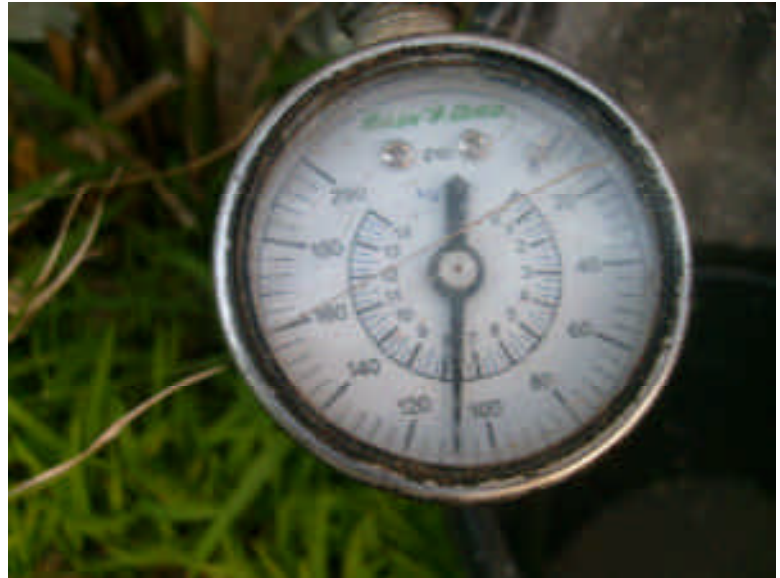
**WATER PRESSURE:**

**Not Acceptable: The pressure is over 80 psi. (110 psi was measured) This is too high, it should be between 40 and 80. A pressure regulator should be installed to bring it into proper range.**

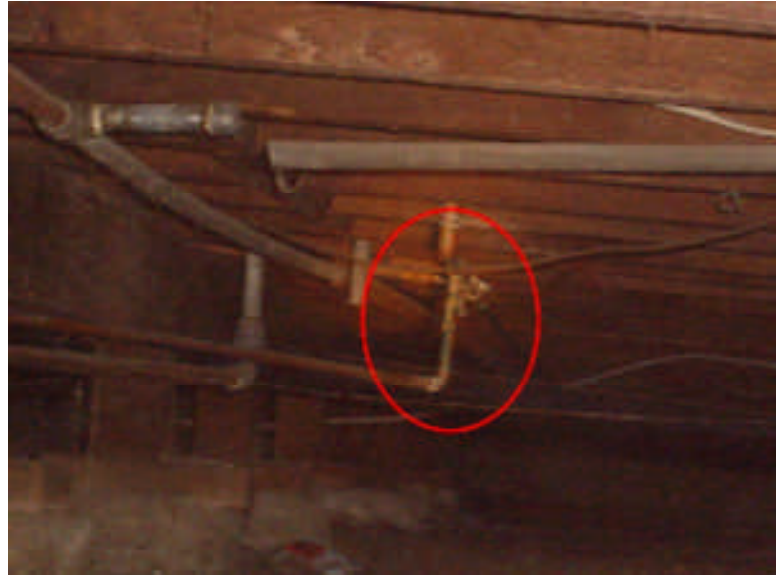
CONDITION:

Needs Attention: The water lines are a combination of copper and galvanized steel piping. The original galvanized steel piping that is left in the system has rust and is showing deterioration. Some of the original pipes have been replaced with copper piping as they wore out, which is why there is copper in the system. The remaining galvanized steel pipes will need to be replaced in the future as they continue to wear out.

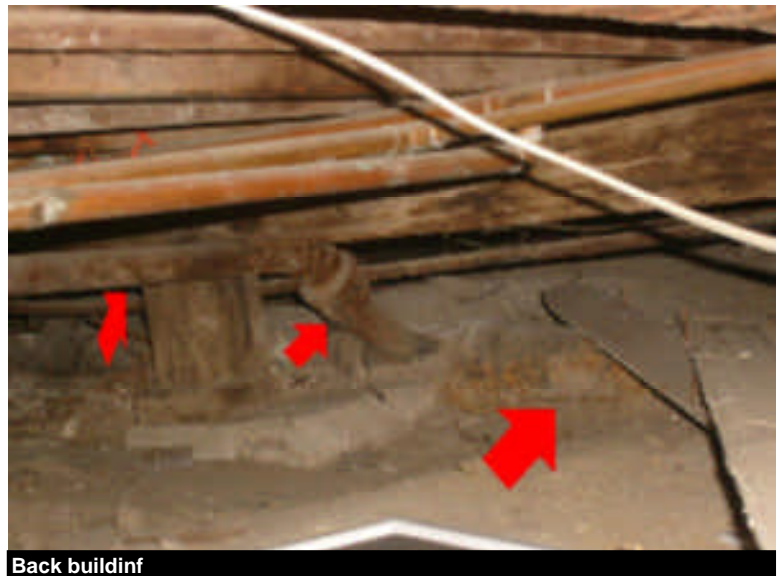
CONDITION:

Needs Attention: There are rusty areas on the exterior of the waste lines. It is not possible to tell when but they will need replacing in the future as they continue to wear out.

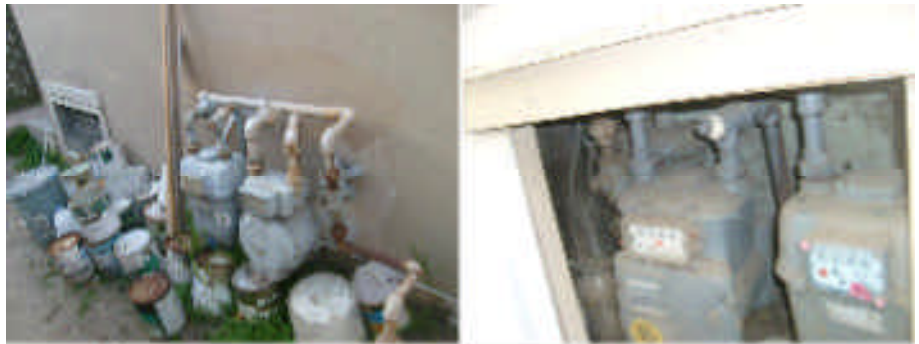
GAS METER  
LOCATION:

The gas meters are located around the outside of each building.

It is advised to have the gas provider inspect the gas system to determine its condition and check all the gas appliances and fixtures. This is usually a free service.

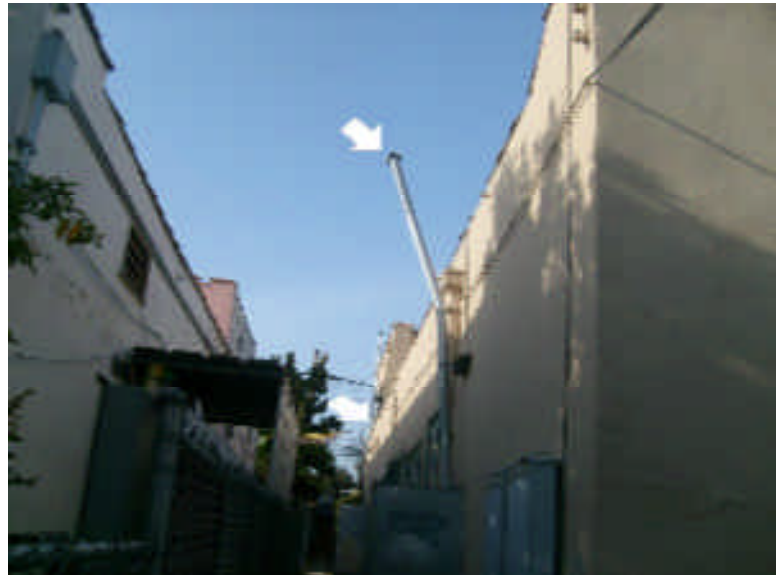
**VENTING:**

**Not Acceptable:** the front right unit the vent line is disconnected and exhaust gases from the water heater are escaping. This is a safety hazard and needs to be repaired.

Two on the left side have loose unsecured vent pipes which are leaning unsecured.

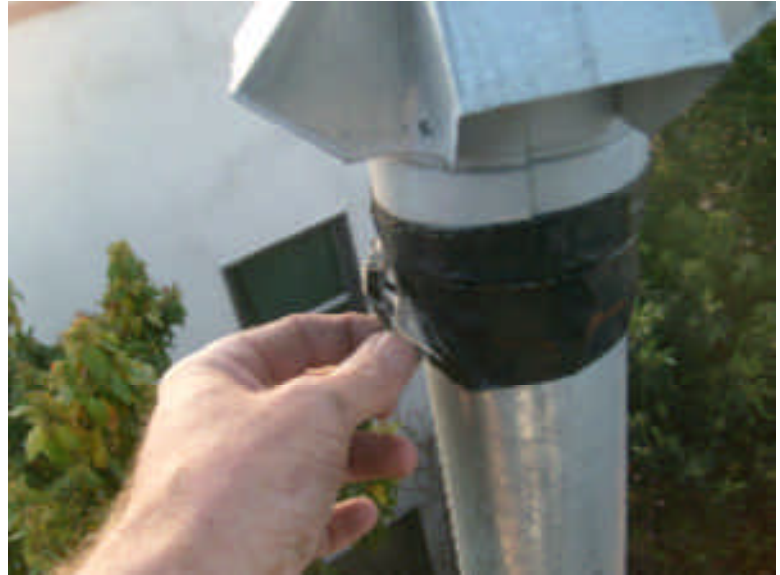
There is duct tape on some of the vent pipe caps which is an improper material

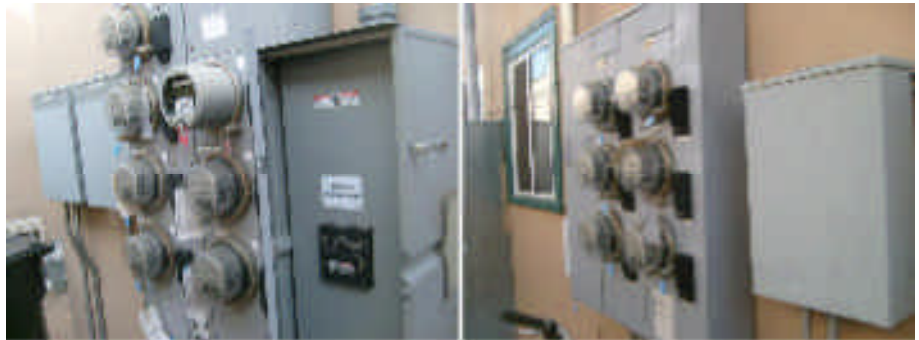
MAIN PANEL  
LOCATION:

There are two clusters of meters; main electrical panel is located on the left side and a cluster of separate power supply meters are on the right side.

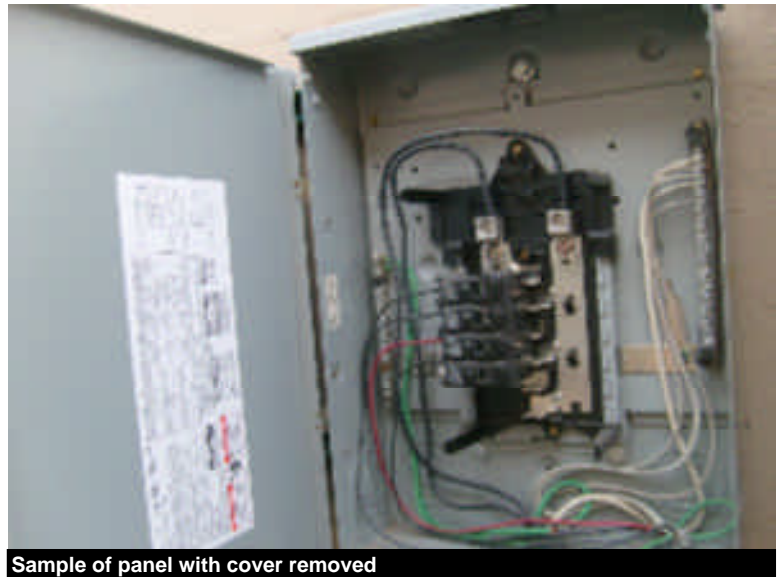
MAIN PANEL  
CONDITION:

Sample of panel with cover removed

Serviceable.

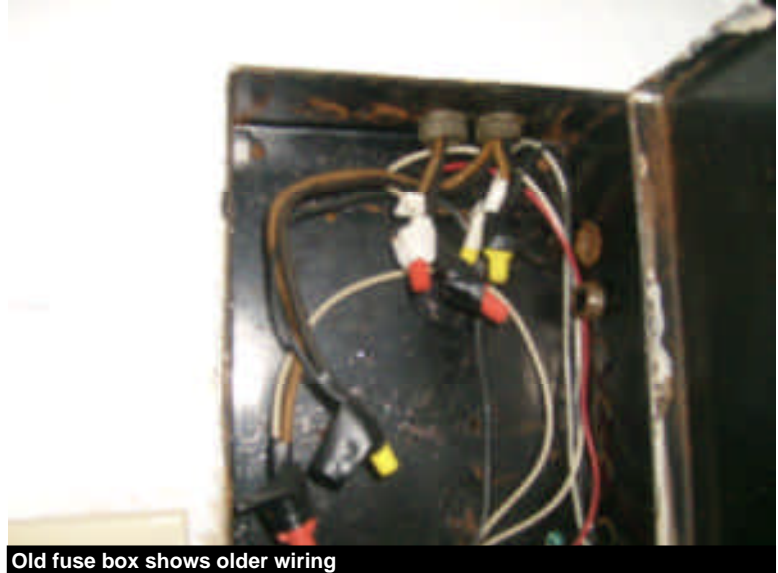
TYPE OF WIRING:

Old fuse box shows older wiring

The wiring is a combination of older, original cloth covered wires and plastic insulated wires.

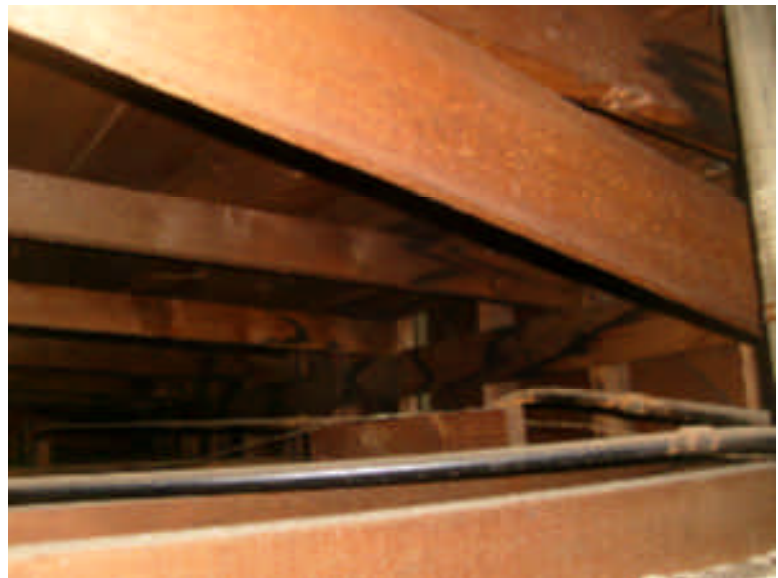
TYPE OF WIRING  
CONDUIT:

The conduit that carries the wiring is a combination of different types.

The conduit seen in the attic that carries the wiring is rigid metal conduit.

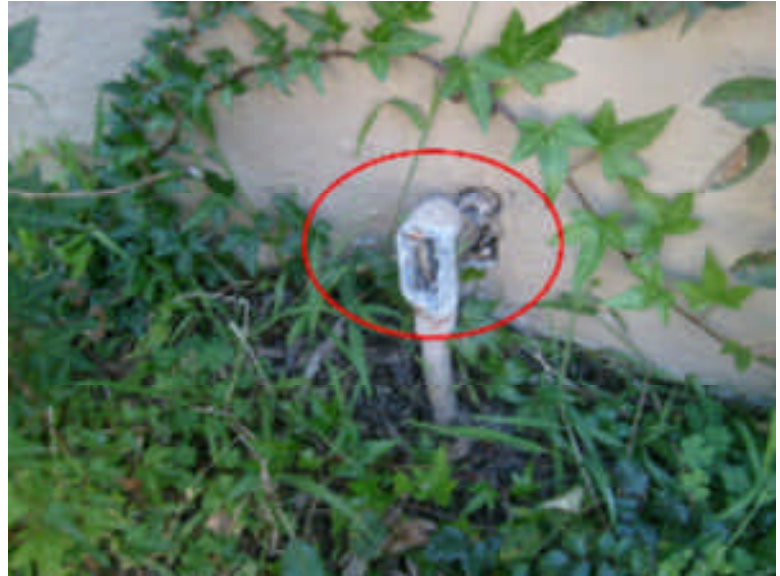
There is a broken and open conduit elbow with exposed wires in the front courtyard on the left.

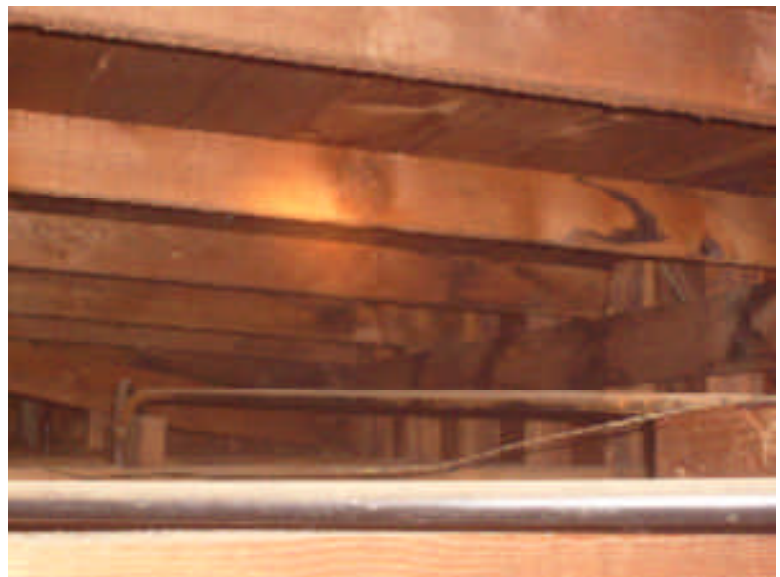
**ATTIC FRAMING CONDITION:**

Serviceable, where visible, though there are areas of stains on the

framing lumber.

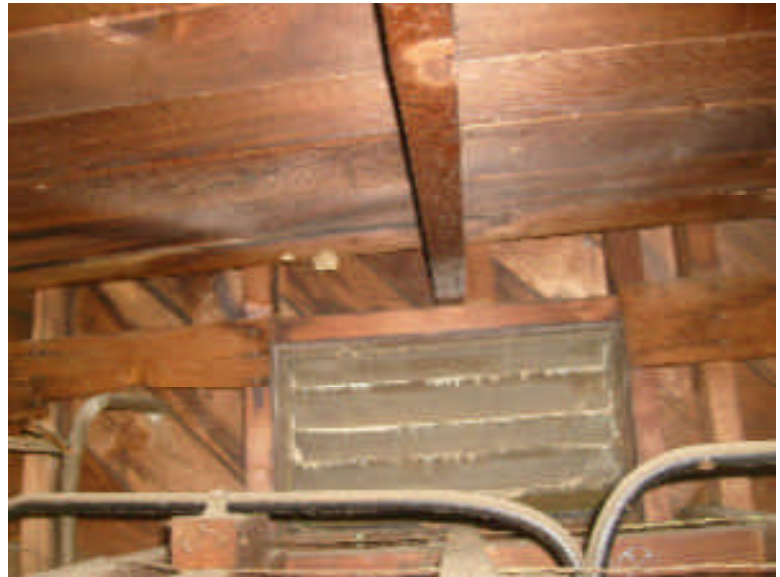
ATTIC VENTILATION:

**Needs Attention:** The vents that supply a fresh air flow to the attic have no screens on them. This may allow animals or insects to enter.

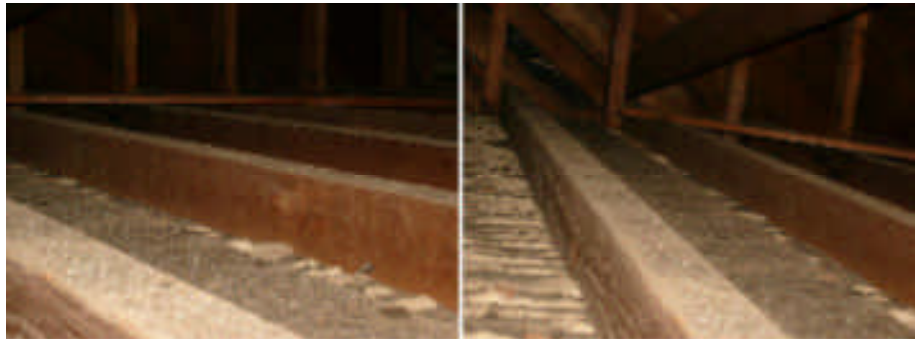
INSULATION  
CONDITION:

**Needs Attention:** No insulation is provided in the attic. Insulation was not commonly installed at the time when this building was constructed. 8 - 12 inches of insulation is standardly recommended in the attic for energy savings.

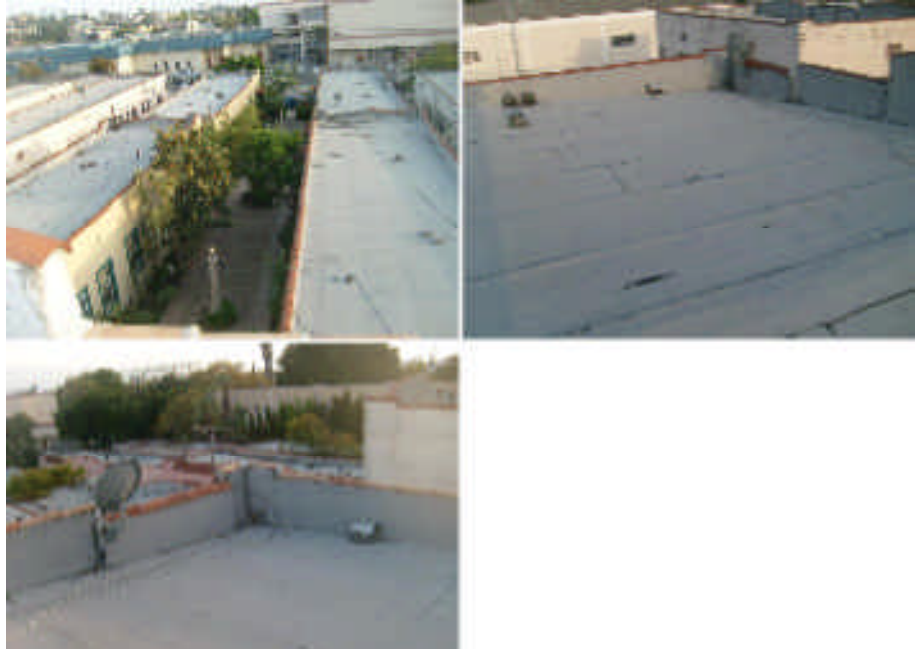
**Upper roof & looking down on lower roofs**

The roofing material on the low sloped roof is rolled composition roofing (BUR or build up roofing or cap sheet)

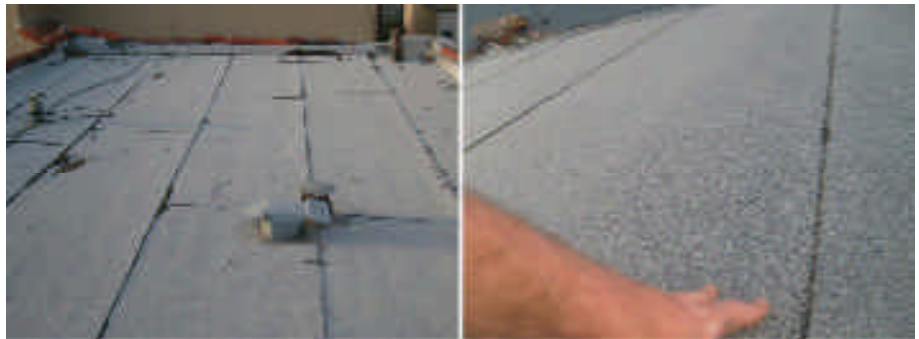
**ROOF COVERING STATUS:**

Needs Attention: On the low sloped / flat roof typically all of the roofs had wrinkles as if this has other layers below which is typically not advised for flat roofing.

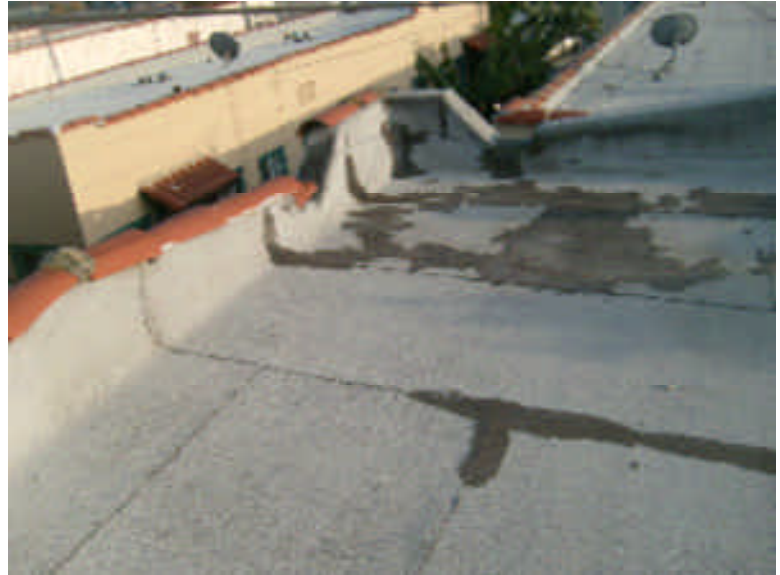
The back left duplex has areas of worn granules and many patched areas.

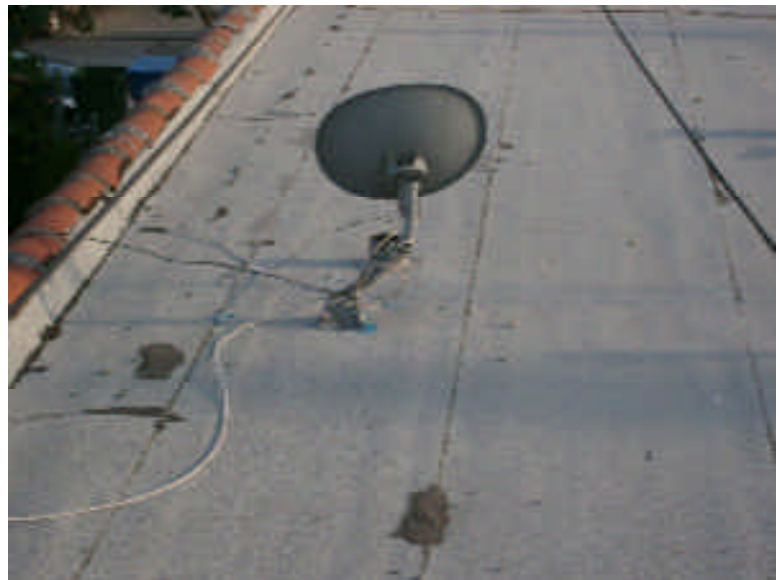
Needs Attention:;, some of the TV satellite dishes are mounted directly down screwed into the roofing material;

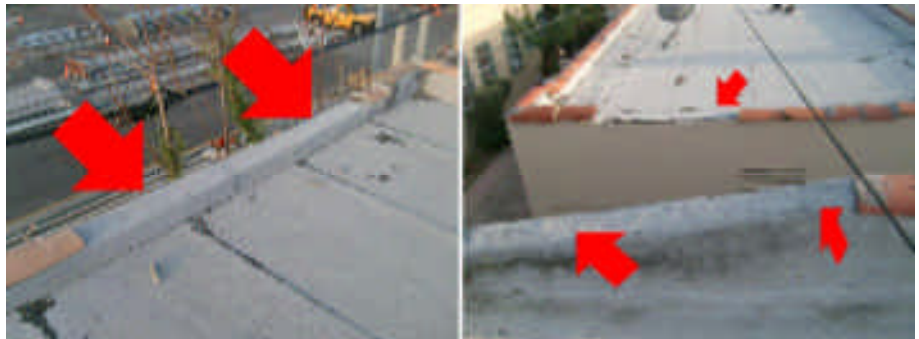
There are many tiles missing along the parapet walls.

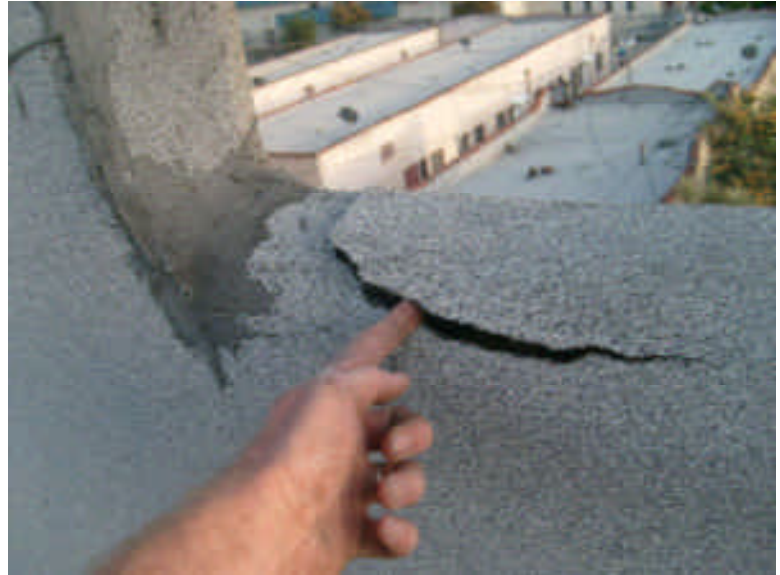
There is a torn cap sheet along the front edge of the back building.

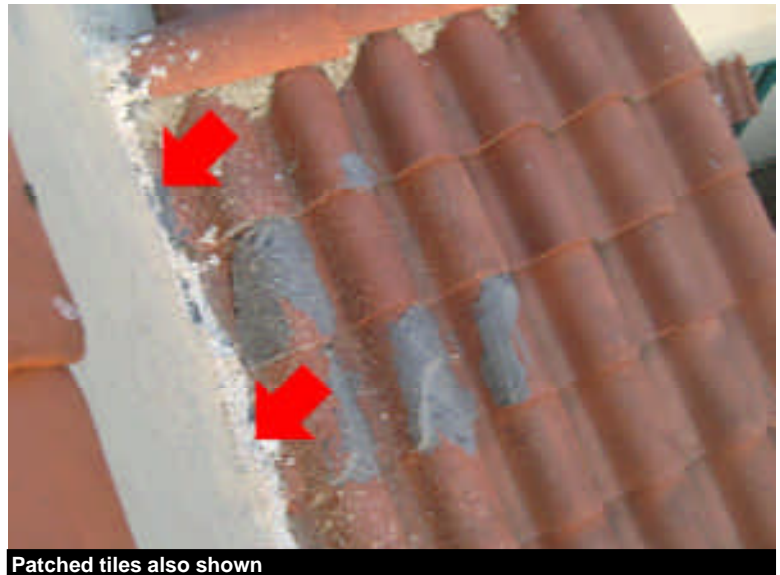
Patched tiles also shown

Needs Attention: The connection of the roof to the wall of the building has not been properly flashed and therefore is not a reliable installation. It will require high maintenance in this state.

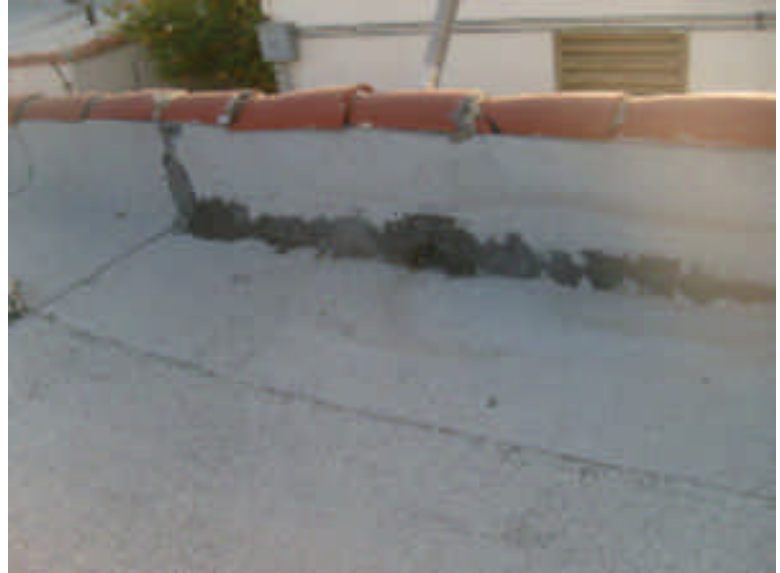
### GUTTER CONDITION:

Needs Attention: There are 'scupper' drains through the side (parapet) walls of the building to let water off the roof. It is recommended that an overflow scupper drain be added about 2 inches above the main drain to prevent ponding and flooding.

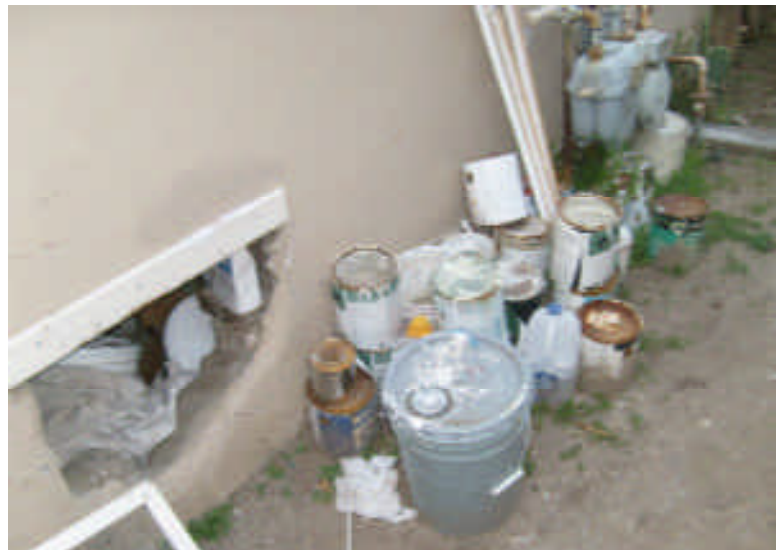
**Back left building**

Needs Attention:, there are many areas which are too small to enter such as in the back unit. The front right unit does not have a proper access and could not be entered at all. The back left building has stored construction materials. This material and the paint supplies/ combustible materials on the exterior near the opening should be removed.

The crawl space has debris in it, it is advisable to have it removed and the area cleaned up. Wood / cellulose especially should be removed to help prevent future infestations,

Two of the accesses are non standard and appear to have been notched out oddly.

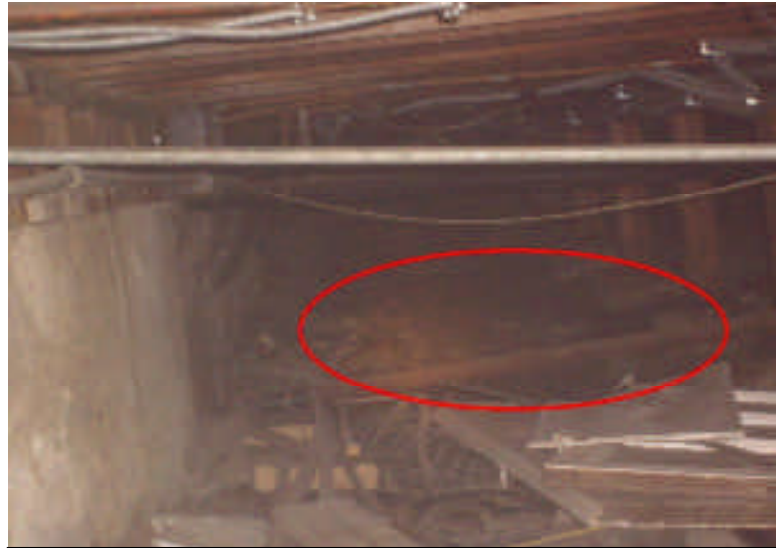
**Dark and damp soil**

There are areas of excessive dampness in the soil under the back left building. This may cause the building to feel damp and create the growth of mold and/or mildew. It is advised to have this examined by specialists to have the source of the moisture detected and any needed corrections performed plus any growth properly abated

Some drainage corrections are needed.

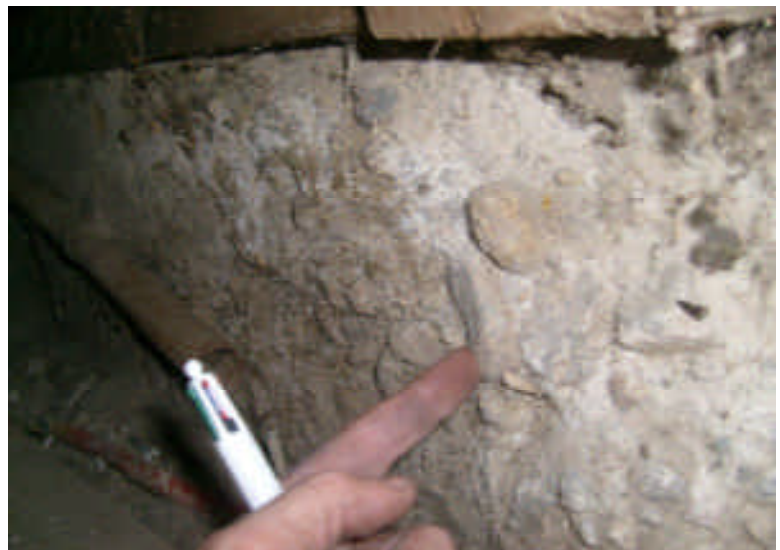
**Older foundation with round aggregate**

Needs Attention, this is an older foundation and showing wear and deterioration and the concrete foundation has some typical cracking, but was in functional condition for a building of this age. It does not appear to be significant at this time. If a more detailed evaluation is required, it could be obtained from a structural engineer or foundation specialist.

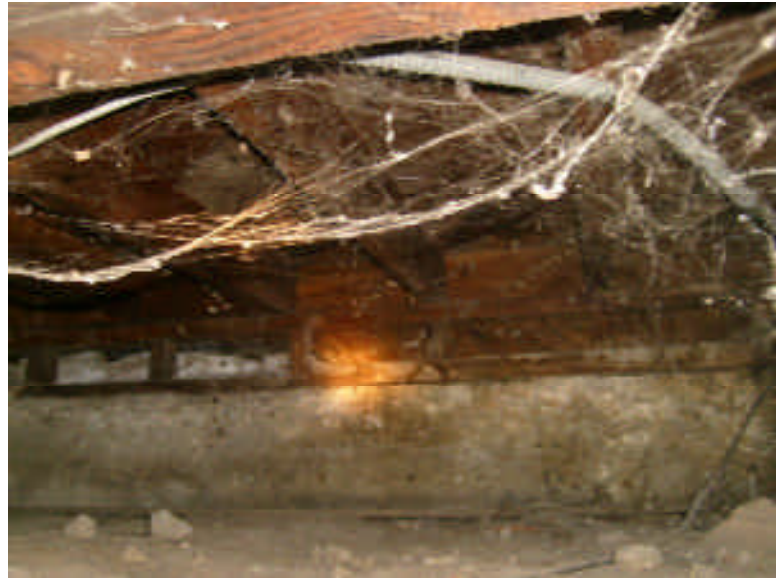
**FOUNDATION  
CRIPPLE WALLS:**

Needs Attention: The cripple walls, or portions of it, have not been strengthened with seismic reinforcement (shear panels etc). 'Cripple walls' are short walls between the foundation and the under side of the building framing. Although this may not be required, seismic reinforcement would help reduce damage to the structure during seismic activity. For detailed information consult with a foundation specialist.

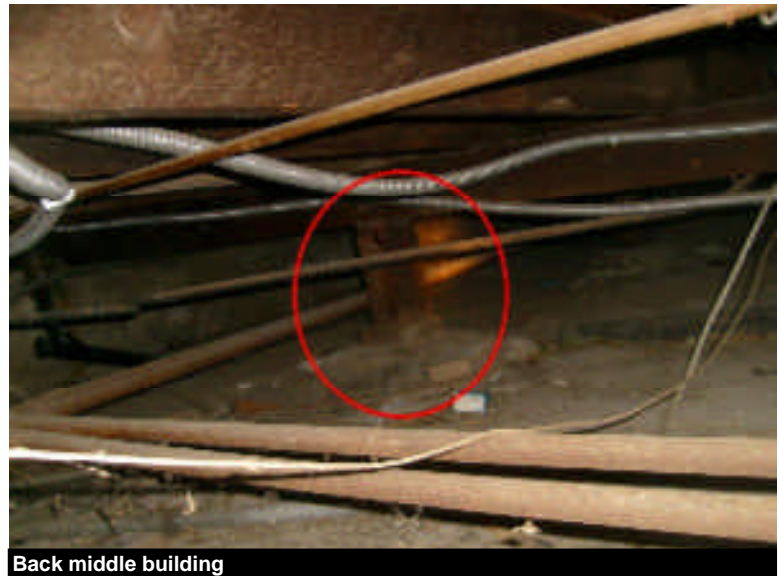
**POSTS AND PIERS:**

Needs Attention:, Some posts have shifted and are out of plumb.

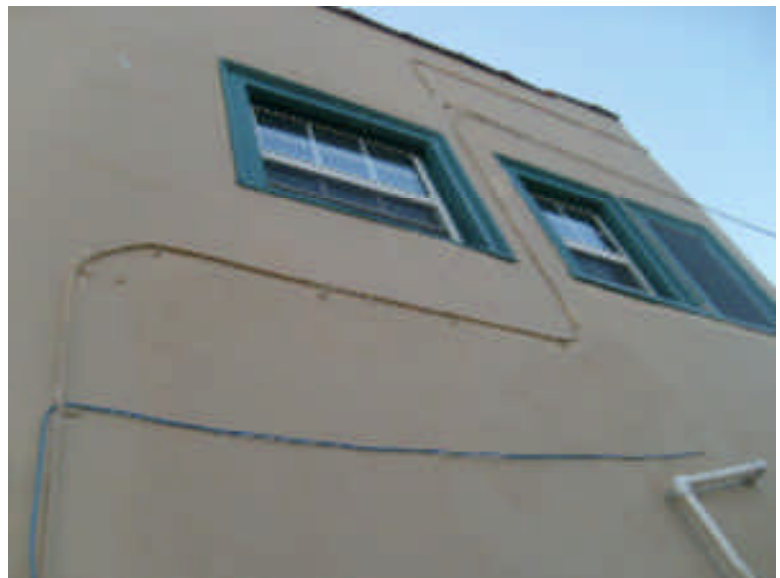
**MATERIAL:**

The exterior window surfaces are various types of materials.

Most of the windows have been upgraded.

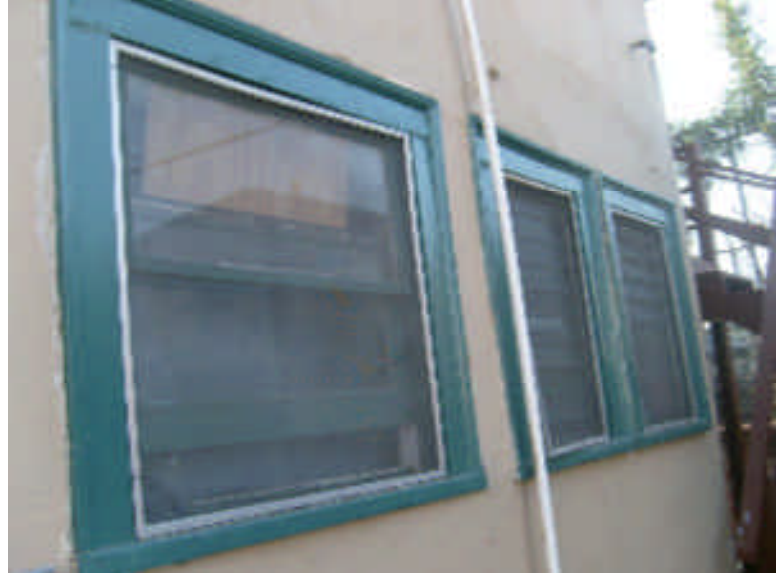
Needs Attention: There are areas of weather beaten wood and peeling paint on the older wood windows.

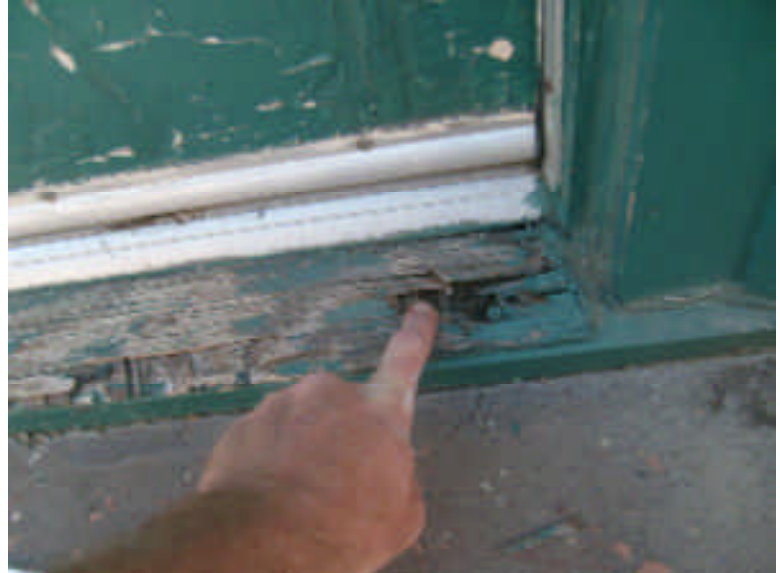
**Not Acceptable:** there are some rooted sections such as on the right side, see the pest control report for more information.

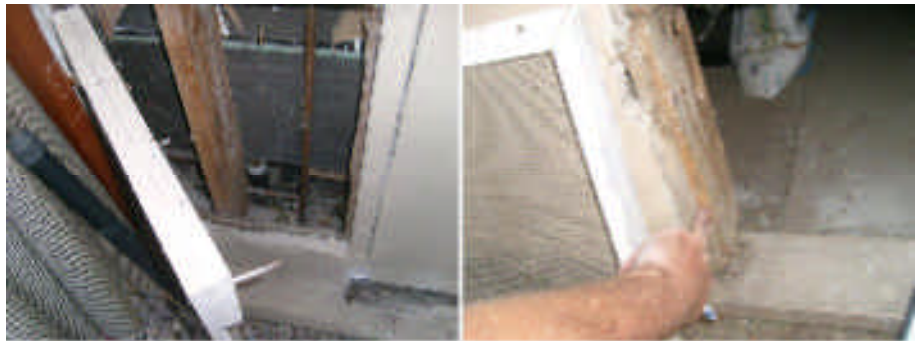
**Needs Attention:** The trim is deteriorated in areas such as at some of the plumbing access doors in the back and at thee crawl space openings, see the pest control report for more information. .

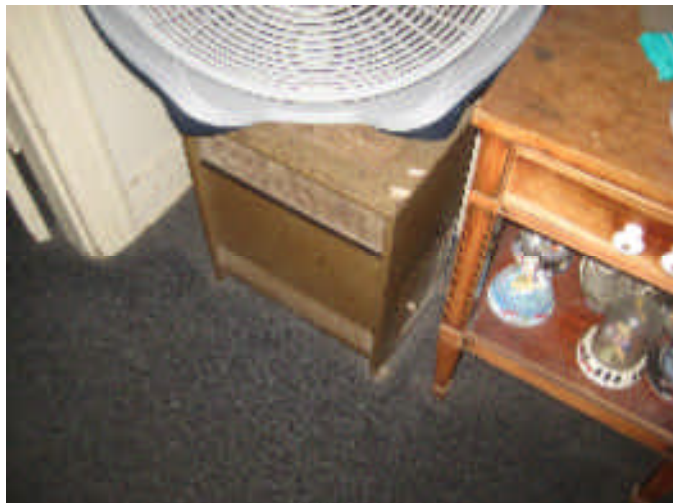
**HEATING**

**Needs Attention: the furnace is old and past its expected life.** The gas furnace does not appear to be being used. It is dirty and the pilot is off. It will need to be cleaned, serviced and tested before being returned to use.

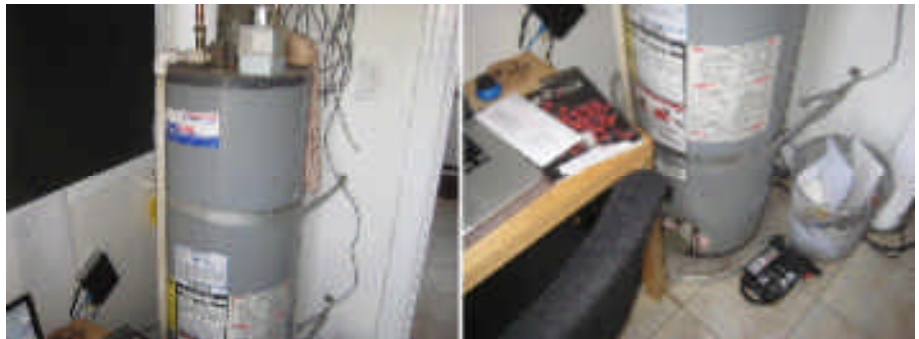
WATERHEATER:

it is gas fired, 30 gallons, The water heater is old and near / at the end of it's expected working life.

CONDITION: **Needs Attention:** The Relief Valve drain is made of plastic, this should be metal as plastic will not stand up to possible heat of discharge.

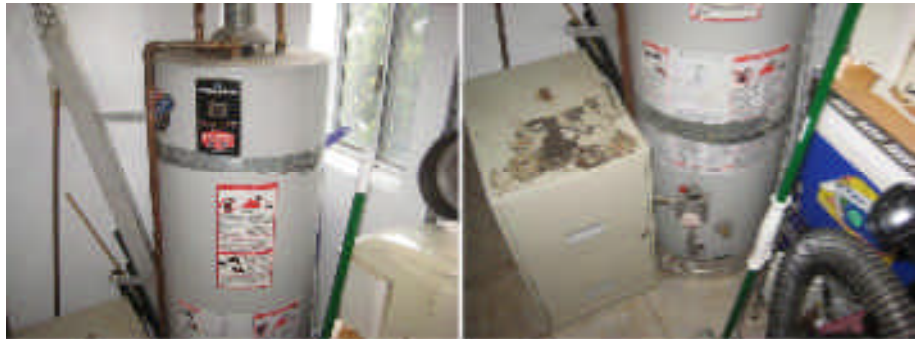
WATERHEATER:

it is gas fired, 30 gallons, 8 years old, The water heater is old and well into it's expected working life.

**CONDITION: Needs Attention: The water heater is not fully strapped and secured in position as required by current standards.**
